**Flood Control Project Maintenance  
Levee Inspections**

**Fall 2018 Levee Maintenance Deficiency Summary Report**

<b>RD0544</b>	Overall LMA Rating	Total LMA Miles						
<b>Reclamation District No. 0544 Upper Roberts Island</b>	<b>U</b>	<b>10.20</b>						
Rated Item	Maintenance Deficiency				Enforcement		Design & System Obsolescence	
	M Miles	U Miles	M + 4U Miles	Threshold %	M Miles	U Miles	M Miles	U Miles
<i>Earthen Levee</i>								
Vegetation	1.18	4.95	20.98	205.66%		0.07		
Trim / Thin Trees	0.24	0.09	0.60	5.88%				
Encroachments	0.02	0.02	0.10	0.98%	0.39	0.11		
Animal Control	0.57	0.27	1.65	16.17%				
Slope Stability	0.04	0.01	0.08	0.78%				
Erosion / Bank Caving	0.03	0.09	0.39	3.82%				
Crown Surface / Depressions / Rutting	0.22		0.22	2.16%				
Flood Preparedness & Training	0.10		0.10	0.98%				
<i>Interior Drainage &amp; Piping Systems</i>								
Erosion Areas		0.01	0.04	0.39%				
<i>Supplemental</i>								
DWR Erosion Survey	0.04		0.04	0.39%				
DWR UCIP Field Study					0.19	0.05		
<i>LMA Totals:</i>	2.44	5.44	24.20	237.22%	0.58	0.23	0.00	0.00

**Flood Control Project Maintenance  
Levee Inspections****LMA District Cover Sheet****Fall 2018 Levee Inspection Results****Rec

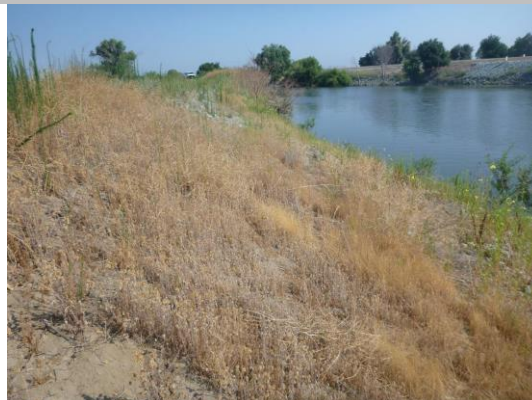
Photo 1 of 3 : LEVAL\_FA\_2018\_564\_4748.jpg

Item	2017 Storm Damage			37.831300°	37.830700°
				-121.312600°	-121.312300°
DWR ID	DWR_RD0544_01_f_2017_133				
Comment Code					
Inspector Comment					
<p>Levee Evaluation Comments</p> <p>Description: Slope protection repairs are needed along the waterside slope due to erosion and riprap displacement from high water. Based upon levee inspections, it was determined the waterside levee slope is eroding, deteriorating, and degrading. The eroded levee sections need to be restored back to design standards to prevent further deterioration and damage.</p> <p>Site ID No: 564</p> <p>Site Designation: LMA-470</p> <p>Repair Type: Erosion</p> <p>Rating: Area of Concern</p> <p>Field Date: 8/11/2017</p> <p>Notes: big rodent holes on levee slopes</p>

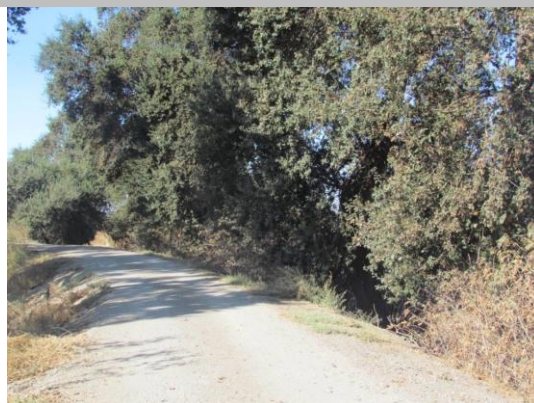
Photo 1 of 1 : FA\_2018\_RD0544\_108\_120\_20180906\_00088.jpg

LM Start	4.25	Rating **	U	Issue No.	120
LM End	4.28	Issue Type +	Ma	Location *	LS
Category	Earthen Levee			GPS Latitude/Longitude	
				Start	End
Item	Trim / Thin Trees			37.825482 °	37.825229 °
				-121.314298 °	-121.314771 °
DWR ID	DWR_RD0544_01_f_2015_120				
Comment Code					
T1 : Trim trees to at least five feet above ground level.					
Inspector Comment					
Several untrimmed trees on landside slope.

Looking southwest at untrimmed trees on landward slope.

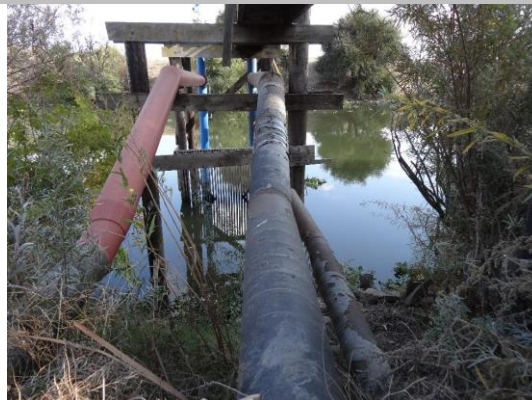
Photo 1 of 3 : UCIP\_FA\_2018\_24893\_44858.jpg

Comment Code					
Inspector Comment					
FS_ID:24893 DS_ID:22660 EP_NO: 11536 Repair Type: Non-Urgent Crossing Status: Found UCIP Comments: - siphon breaker was removed from CMP riser on landside shoulder. Needs replacement.- some details about existing pipes available in new Application no. 18903.- electric control box on landside and conduit on waterside. FIELD_STRUCT_DESC: 1 of 3: 12-inch coated steel irrigation discharge pipe through the levee, 3 feet below the crown. Pump on a pumping platform in the river with a walkway from the waterside (WS) slope. Siphon breaker in a corrugated metal pipe (CMP) riser and a concrete standpipe on the landside (LS). (Plans to install a platform and two irrigation pumps with two irrigation pipes and a drainage pipe through the levee, replacing an existing pump and irrigation pipe, authorized under Permit No. 11536, 1976 - Lloyd L. Phelps Sr). [Additional Reference(s): DWR Levee Log, 2005. USACE San Joaquin O&M Manual 7, April 1964, (HLM 4.33), pipe referenced as 8 feet below the crown]. FS Date: 10/29/2013

WS view: pipes, pumps, walkway to pump, and pile structure in the stream.

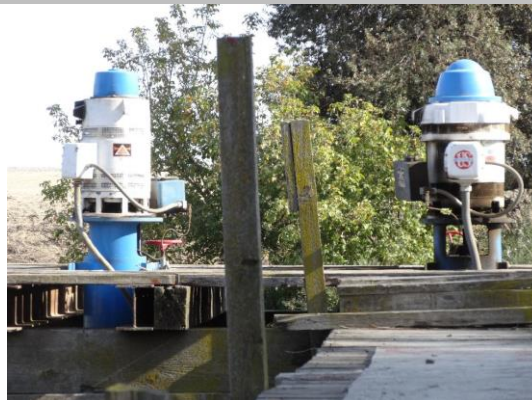
Photo 2 of 3 : UCIP\_FA\_2018\_24893\_44857.jpg

WS view: pumps, walkway to pump, and pile structure in the stream.

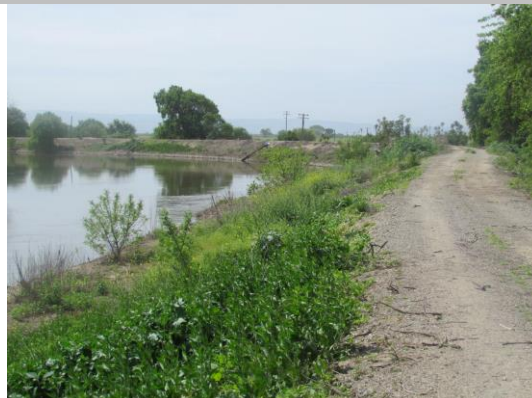
Photo 2 of 2 : FA\_2018\_RD0544\_108\_117\_20180906\_00083.jpg

LM Start	4.41	Rating **	U	Issue No.	117 (cont)	
LM End	4.79	Issue Type +	Ma	Location *	WS	
Category	Earthen Levee			GPS Latitude/Longitude		
				Start		End
Item	Vegetation			37.823522 °		37.820557 °
				-121.315735 °		-121.321217 °
DWR ID	DWR_RD0544_01_s_2017_117					
Comment Code						
V2 : Remove the wild growth other than native grasses from the levee slopes.						
Inspector Comment

Looking south at dense veg on waterward slope.

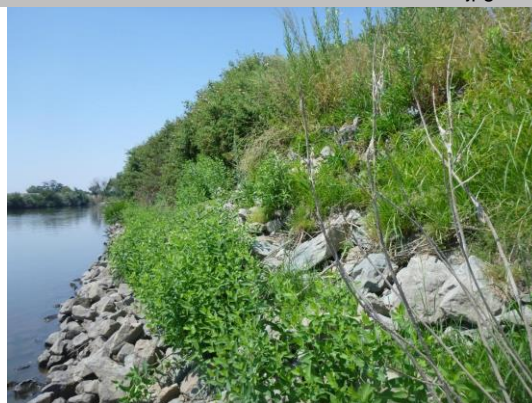
Photo 1 of 3 : LEVAL\_FA\_2018\_561\_4862.jpg

Comment Code					
Inspector Comment					
Levee Evaluation Comments					
Description:Slope protection repairs are needed along the waterside slope due to erosion and riprap displacement from high water. Based upon levee inspections, it was determined the waterside levee slope is eroding, deteriorating, and degrading. The eroded levee sections need to be restored back to design standards to prevent further deterioration and damage.					
Site ID No:561					
Site Designation:LMA-467					
Repair Type: Erosion					
Rating:Area of Concern					
Field Date:8/11/2017					
Notes: site combined with LMA-466 in field; length and coordinates redefined in field.

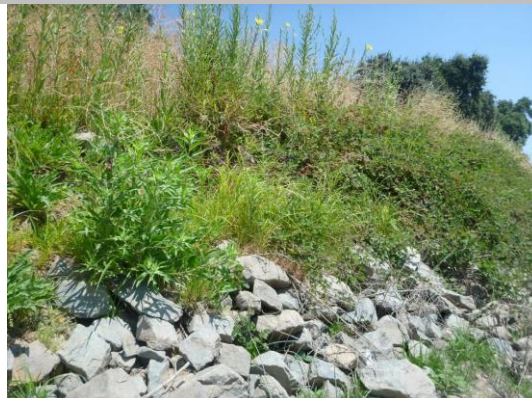
Photo 2 of 3 : LEVAL\_FA\_2018\_561\_4866.jpg

Item	2017 Storm Damage			37.823200 °	37.823000 °	
				-121.316400 °	-121.316800 °	
DWR ID	DWR_RD0544_01_f_2017_136					
Comment Code						
Inspector Comment						
Levee Evaluation Comments						
Description:Slope protection repairs are needed along the waterside slope due to erosion and riprap displacement from high water. Based upon levee inspections, it was determined the waterside levee slope is eroding, deteriorating, and degrading. The eroded levee sections need to be restored back to design standards to prevent further deterioration and damage.						
Site ID No:561						
Site Designation:LMA-467						
Repair Type: Erosion						
Rating:Area of Concern						
Field Date:8/11/2017						
Notes: site combined with LMA-466 in field; length and coordinates redefined in field.

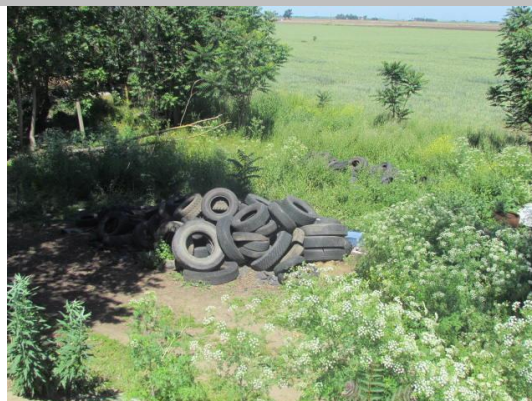
Photo 1 of 1 : FA\_2018\_RD0544\_108\_27\_20180906\_00025.jpg

LM Start	4.68	Rating **	U	Issue No.	27
LM End	4.69	Issue Type +	En	Location *	LS
Category	Earthen Levee			GPS Latitude/Longitude	
				Start	End
Item	Encroachments			37.821847 °	37.821793 °
				-121.320027 °	-121.320188 °
DWR ID	DWR_RD0544_01_s_2012_27				
Comment Code					
GA : Garbage					
Inspector Comment					
Tires stock pile on landside toe.

Looking west at tires stock pile on landward berm.

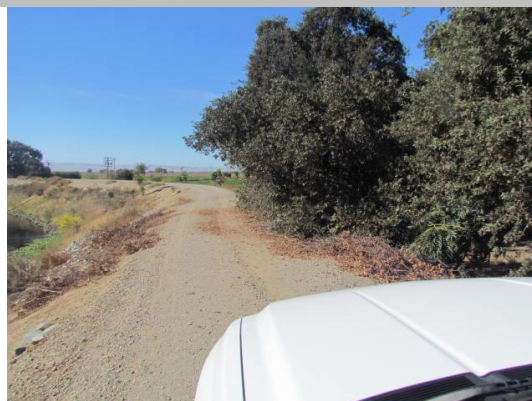
Photo 1 of 1 : FA\_2018\_RD0544\_108\_105\_20180906\_00072.jpg

LM Start	4.69	Rating **	U	Issue No.	105
LM End	4.69	Issue Type +	Ma	Location *	LS
Category	Earthen Levee			GPS Latitude/Longitude	
				Start	End
Item	Trim / Thin Trees			37.821775 °	37.821775 °
				-121.320203 °	-121.320203 °
DWR ID	DWR_RD0544_01_f_2014_105				
Comment Code					
T2 : Thin trees to allow visibility of the ground and room to flood fight.					
Inspector Comment					
Tree has overgrown onto levee crown.

Looking south at overgrown tree on landward shoulder.

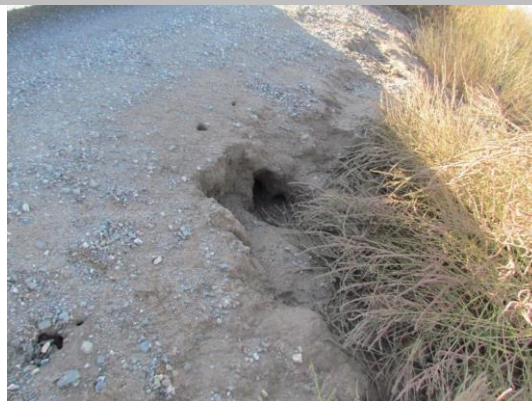
Photo 1 of 1 : FA\_2018\_RD0544\_108\_83\_20180906\_00060.jpg

LM Start	4.74	Rating **	U	Issue No.	83
LM End	4.74	Issue Type +	Ma	Location *	LS
Category	Earthen Levee			GPS Latitude/Longitude	
				Start	End
Item	Animal Control			37.821287 °	37.821287 °
				-121.320897 °	-121.320897 °
DWR ID	DWR_RD0544_01_f _ 2016_83				
Comment Code					
A3 : No rodents visible, but rodent burrows visible; need to backfill and compact or grout burrows.					
Inspector Comment					
Large rodent hole on waterside shoulder.

Looking at large rodent hole on landward slope.

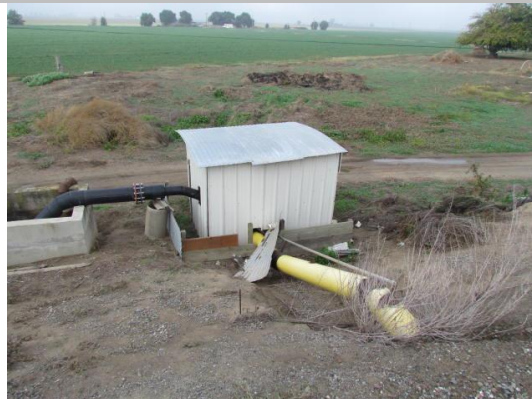
Photo 1 of 1 : FA\_2018\_RD0544\_108\_45\_20180906\_00035.jpg

LM Start	4.75	Rating **	M	Issue No.	45
LM End	4.75	Issue Type +	En	Location *	LS
Category	Earthen Levee			GPS Latitude/Longitude	
				Start	End
Item	Encroachments			37.821177 °	37.821177 °
				-121.321013 °	-121.321013 °
DWR ID	DWR_RD0544_01_s_2012_45				
Comment Code					
BU : Building					
Inspector Comment					
New unauthorized pump shed on landside toe.

Looking west at a unauthorized pump house on landside toe.

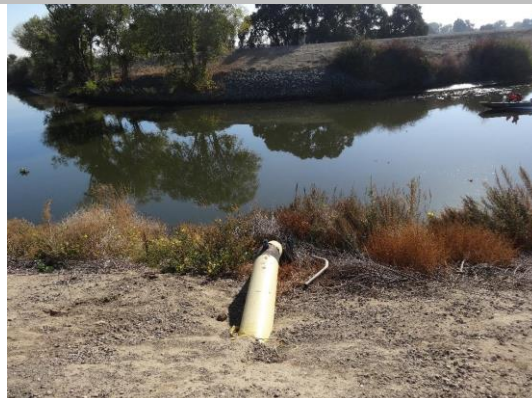
Photo 1 of 3 : UCIP\_FA\_2018\_53364\_44864.jpg

Comment Code						
Inspector Comment						
FS_ID:53364 DS_ID:22661 EP_NO: N/A Repair Type: Urgent Crossing Status: Found UCIP Comments: 10/2/2018 Same as last inspection; LS slope shows both signs of erosion and a hole above the pipe so crossing remains Urgent (D. Sanoski - DWR UCIP).12/22/2016: LS slope still eroded and in need of repair. WS slope shows no signs of problems. (K. Fazel - UCIP)10/31/2013:- huge erosion on landside slope due to leaky pipe.- small depression on waterside slope. (P. Amatya - DWR) FIELD_STRUCT_DESC: 12-inch steel irrigation discharge pipe through the levee, 4.4 feet below the crown. Pump house on the landside (LS) slope. Newly installed pump with a shutoff valve on the waterside (WS) slope. Pressure relief valve on the LS slope. Concrete distribution box with a shutoff valve on the pipe at the LS toe. [Additional Reference(s): DWR Levee Log, 2005. USACE San Joaquin O&M Manual 7, April 1964, (HLM 4.79), 14-inch pipe, 12 feet below the crown, referenced]. FS Date: 10/2/2018 3:22:00 PM

WS view: exposed steel pipe on levee slope.

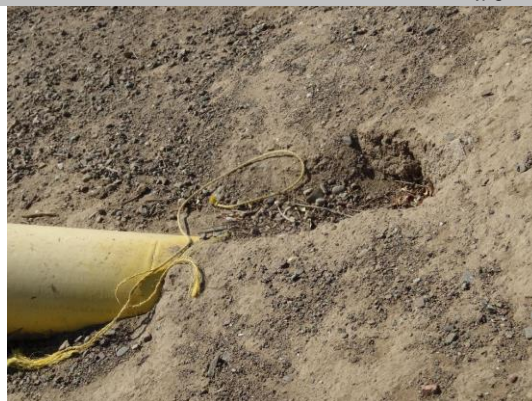
Photo 2 of 3 : UCIP\_FA\_2018\_53364\_44863.jpg

WS view: exposed steel pipe and a small depression on levee slope.  
May be due to leaky pipe.

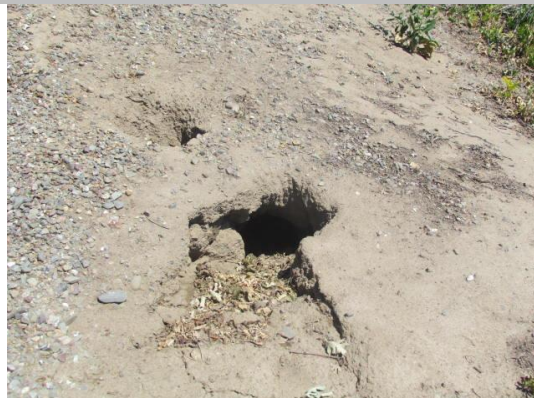
Photo 1 of 1 : FA\_2018\_RD0544\_108\_113\_20180906\_00078.jpg

LM Start	4.77	Rating **	U	Issue No.	113
LM End	4.77	Issue Type +	Ma	Location *	WS
Category	Earthen Levee			GPS Latitude/Longitude	
				Start	End
Item	Animal Control			37.820828 °	37.820828 °
				-121.321193 °	-121.321193 °
DWR ID	DWR_RD0544_01_s_2015_113				
Comment Code					
A3 : No rodents visible, but rodent burrows visible; need to backfill and compact or grout burrows.					
Inspector Comment					
Large hole, possibly a rodent hole, on waterside slope.

Looking north at large hole on waterward slope.

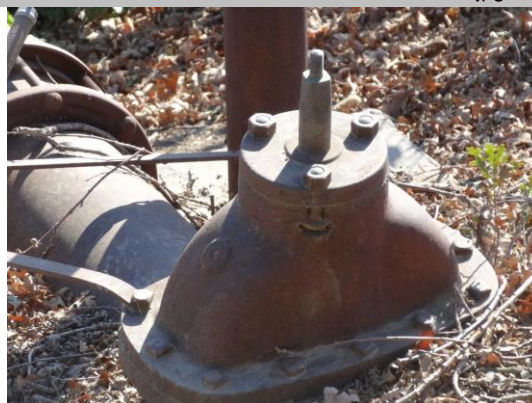
Photo 2 of 3 : UCIP\_FA\_2018\_42962\_42876.jpg

Comment Code						
Inspector Comment						
FS_ID:42962 DS_ID:22662 EP_NO: 1738 Repair Type: Non-Urgent Crossing Status: Found UCIP Comments: Appears abandoned and if so should be done so properly. No handle on gatevalve on WS slope. FIELD_STRUCT_DESC: 12-inch steel irrigation discharge pipe through the levee, 6 feet below the crown. Slant pump and gate valve on the waterside (WS) slope. Electrical conduit through the levee and on the landside (LS). Service pole on the LS. Two concrete standpipes on the LS. (Plans for the construction of a pipeline through the levee authorized under Permit No. 1738, 1953 - Barker Corporation). [Additional Reference(s): DWR Levee Log, 2005. USACE San Joaquin O&M Manual 7, April 1964, (HLM 4.82)]. FS Date: 10/31/2013

WS view: gate valve without handwheel on levee slope.

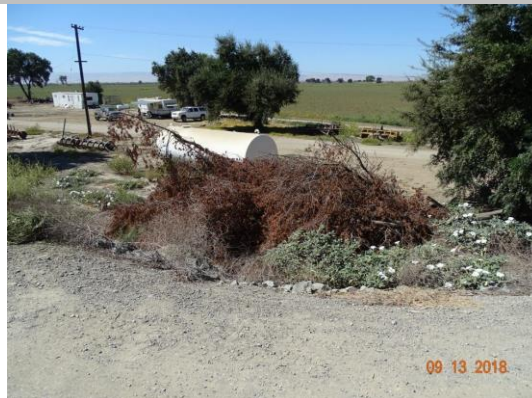
Photo 1 of 1 : FA\_2018\_RD0544\_108\_52\_20180919\_00178.jpg

LM Start	4.80	Rating **	U	Issue No.	52
LM End	4.80	Issue Type +	Ma	Location *	LS
Category	Earthen Levee			GPS Latitude/Longitude	
				Start	End
Item	Encroachments			37.820472°	37.820472°
				-121.321190°	-121.321190°
DWR ID	DWR_RD0544_01_f_2018_52				
Comment Code					
PR : Prunings					
Inspector Comment

Looking west at large pruning pile at landward toe. (Fall 2018)

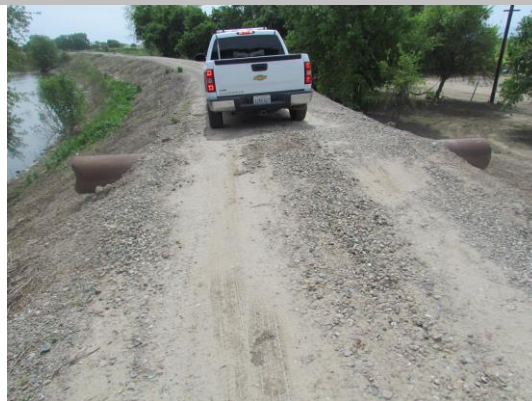
Photo 1 of 1 : FA\_2018\_RD0544\_108\_28\_20180906\_00026.jpg

LM Start	4.80	Rating **	M	Issue No.	28
LM End	4.80	Issue Type +	En	Location *	CR
Category	Earthen Levee			GPS Latitude/Longitude	
				Start	End
Item	Encroachments			37.820412 °	37.820412 °
				-121.321193 °	-121.321193 °
DWR ID	DWR_RD0544_01_s_2017_28				
Comment Code					
PI : Pipe					
Inspector Comment					
Pipe installed near surface of crown. Pipe is not connected on either side.

Looking south at pipe across levee crown.

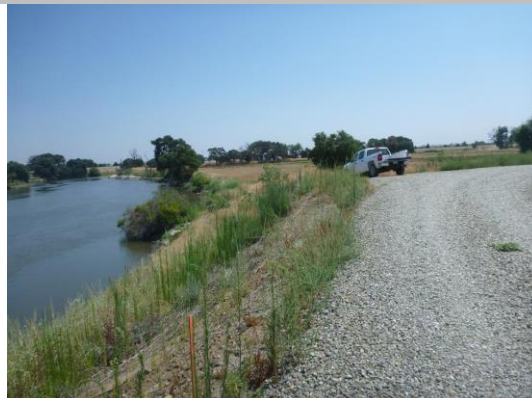
Photo 1 of 3 : LEVAL\_FA\_2018\_559\_4887.jpg

LM Start	4.97	Rating **	A/W	Issue No.	139
LM End	4.99	Issue Type +	Ma	Location *	
Category	Supplemental			GPS Latitude/Longitude	
				Start	End
Item	2017 Storm Damage			37.818600 °	37.818400 °
				-121.319200 °	-121.319000 °
DWR ID	DWR_RD0544_01_f_2017_139				
Comment Code					
Inspector Comment					
Levee Evaluation Comments					
Description:Slope protection repairs are needed along the waterside slope due to erosion and riprap displacement from high water. Based upon levee inspections, it was determined the waterside levee slope is eroding, deteriorating, and degrading. The eroded levee sections need to be restored back to design standards to prevent further deterioration and damage.					
Site ID No:559					
Site Designation:LMA-465					
Repair Type: Erosion					
Rating:Serious					
Field Date:8/11/2017					
Notes:

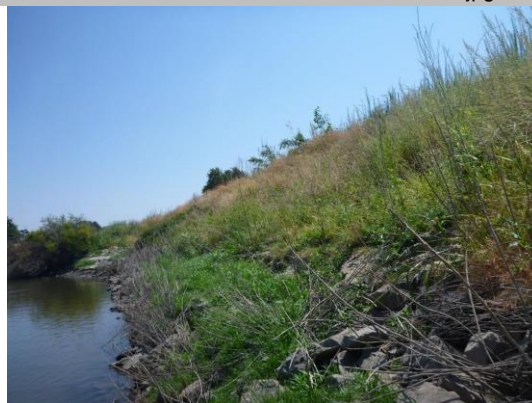
Photo 2 of 3 : LEVAL\_FA\_2018\_559\_4892.jpg

LM Start	<b>4.97</b>	Rating **	A/W	Issue No.	<b>139 (cont)</b>
LM End	<b>4.99</b>	Issue Type +	Ma	Location *

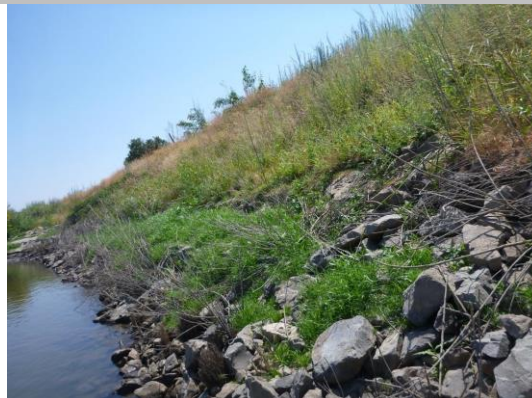
Photo 3 of 3 : LEVAL\_FA\_2018\_559\_4894.jpg

LM Start	<b>4.97</b>	Rating **	A/W	Issue No.	<b>139 (cont)</b>
LM End	<b>4.99</b>	Issue Type +	Ma	Location *	
Category	Supplemental			GPS Latitude/Longitude	
				Start	End
Item	2017 Storm Damage			37.818600°	37.818400°
				-121.319200°	-121.319000°
DWR ID	DWR_RD0544_01_f_2017_139				
Comment Code					
Inspector Comment					
<p>Levee Evaluation Comments</p> <p>Description: Slope protection repairs are needed along the waterside slope due to erosion and riprap displacement from high water. Based upon levee inspections, it was determined the waterside levee slope is eroding, deteriorating, and degrading. The eroded levee sections need to be restored back to design standards to prevent further deterioration and damage.</p> <p>Site ID No: 559</p> <p>Site Designation: LMA-465</p> <p>Repair Type: Erosion</p> <p>Rating: Serious</p> <p>Field Date: 8/11/2017</p> <p>Notes:</p>

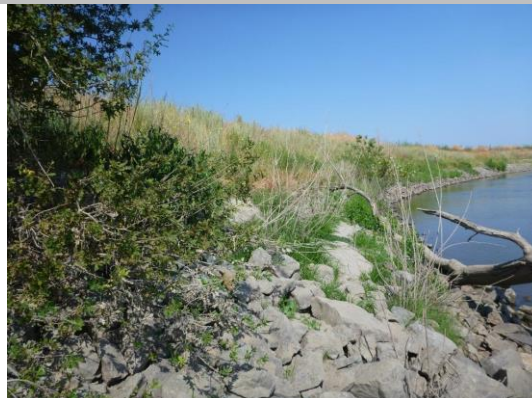
Photo 2 of 3 : LEVAL\_FA\_2018\_558\_4904.jpg

LM Start	5.32	Rating **	A/W	Issue No.	140 (cont)	
LM End	5.36	Issue Type +	Ma	Location *		
Category	Supplemental			GPS Latitude/Longitude		
				Start	End	
Item	2017 Storm Damage			37.813900 °	37.813500 °	
				-121.319900 °	-121.319400 °	
DWR ID	DWR_RD0544_01_f_2017_140					
Comment Code						
Inspector Comment						
Levee Evaluation Comments						
Description:Slope protection repairs are needed along the waterside slope due to erosion and riprap displacement from high water. Based upon levee inspections, it was determined the waterside levee slope is eroding, deteriorating, and degrading. The eroded levee sections need to be restored back to design standards to prevent further deterioration and damage.						
Site ID No:558						
Site Designation:LMA-464						
Repair Type: Erosion						
Rating:Serious						
Field Date:8/16/2017						
Notes:

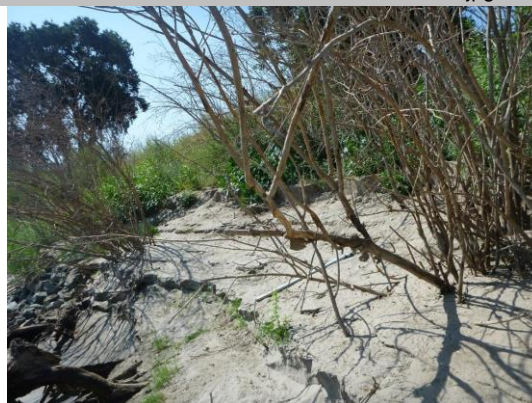
Photo 3 of 3 : LEVAL\_FA\_2018\_558\_4910.jpg

LM Start	<b>5.32</b>	Rating **	A/W	Issue No.	<b>140 (cont)</b>
LM End	<b>5.36</b>	Issue Type +	Ma	Location *

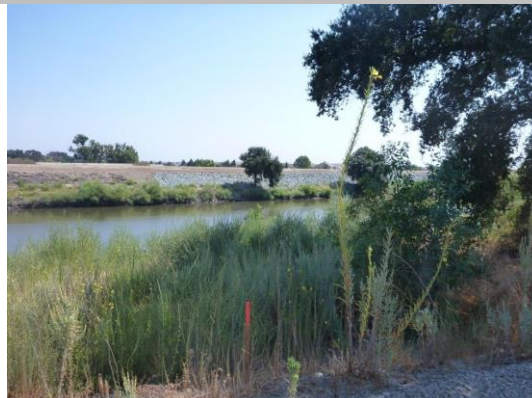
Photo 1 of 3 : LEVAL\_FA\_2018\_557\_4510.jpg

LM Start	5.36	Rating **	A/W	Issue No.	141
LM End	5.37	Issue Type +	Ma	Location *	
Category	Supplemental			GPS Latitude/Longitude	
				Start	End
Item	2017 Storm Damage			37.813400 °	37.813300 °
				-121.319300 °	-121.319200 °
DWR ID	DWR_RD0544_01_f_2017_141				
Comment Code					
Inspector Comment					
Levee Evaluation Comments					
Description:Slope protection repairs are needed along the waterside slope due to erosion and riprap displacement from high water. Based upon levee inspections, it was determined the waterside levee slope is eroding, deteriorating, and degrading. The eroded levee sections need to be restored back to design standards to prevent further deterioration and damage.					
Site ID No:557					
Site Designation:LMA-463					
Repair Type: Erosion					
Rating:Area of Concern					
Field Date:8/16/2017					
Notes:

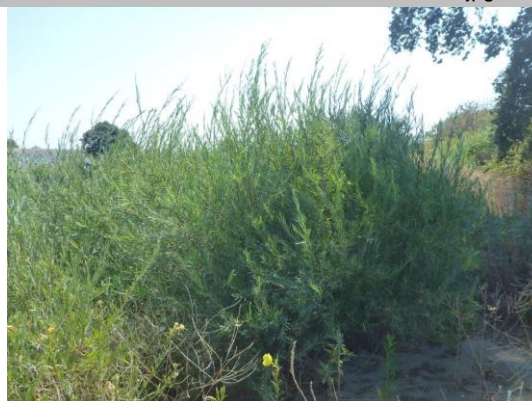
Photo 3 of 3 : LEVAL\_FA\_2018\_557\_4514.jpg

LM Start	5.36	Rating **	A/W	Issue No.	141 (cont)	
LM End	5.37	Issue Type +	Ma	Location *		
Category	Supplemental			GPS Latitude/Longitude		
				Start	End	
Item	2017 Storm Damage			37.813400 °	37.813300 °	
				-121.319300 °	-121.319200 °	
DWR ID	DWR_RD0544_01_f_2017_141					
Comment Code						
Inspector Comment						
Levee Evaluation Comments						
Description:Slope protection repairs are needed along the waterside slope due to erosion and riprap displacement from high water. Based upon levee inspections, it was determined the waterside levee slope is eroding, deteriorating, and degrading. The eroded levee sections need to be restored back to design standards to prevent further deterioration and damage.						
Site ID No:557						
Site Designation:LMA-463						
Repair Type: Erosion						
Rating:Area of Concern						
Field Date:8/16/2017						
Notes:

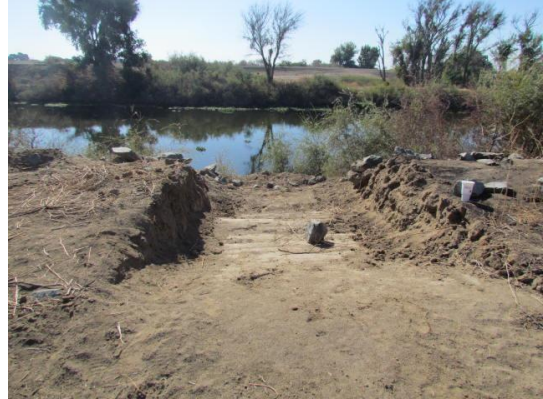
Photo 2 of 4 : FA\_2018\_RD0544\_108\_121\_20180906\_00090.jpg

LM Start	5.60	Rating **	U	Issue No.	121 (cont)
LM End	5.60	Issue Type +	En	Location *	WS
Category	Earthen Levee			GPS Latitude/Longitude	
				Start	End
Item	Encroachments			37.811234 °	37.811234 °
				-121.321412 °	-121.321412 °
DWR ID	DWR_RD0544_01_f_2015_121				
Comment Code					
RA : Ramp					
Inspector Comment					
Someone digging/excavating on waterward berm. Excavation in 3ft wide and eighteen inches deep and ten feet long. Possible boat ramp.

Looking east at excavation on waterward berm.

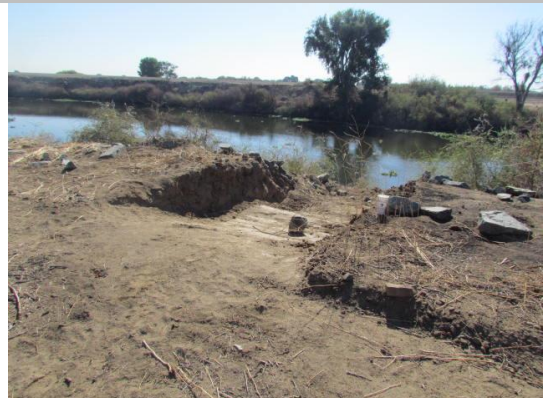
Photo 3 of 4 : FA\_2018\_RD0544\_108\_121\_20180906\_00091.jpg

Looking northeast at excavation on waterward berm

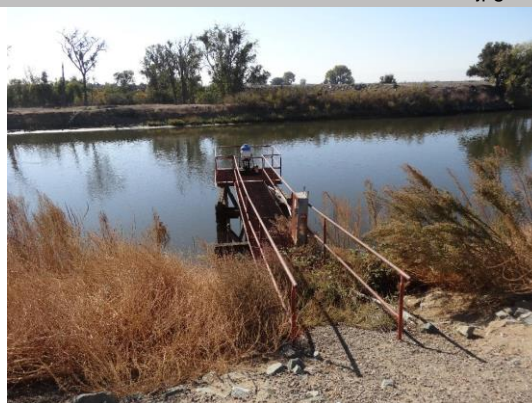
Photo 1 of 3 : UCIP\_FA\_2018\_53365\_42872.jpg

Comment Code						
Inspector Comment						
FS_ID:53365 DS_ID:22664 EP_NO: N/A Repair Type: Non-Urgent Crossing Status: Found UCIP Comments: 10/2/2018 Pump on LS slope has been replaced and the erosion repaired; down-grading to Non-Urgent (D. Sanoski - DWR UCIP).12/22/2016: LS slope just above pipe is eroded with a giant pit exposing the electrical conduit. Crossing has been upgraded from Non-Urgent to Urgent. (K. Fazel - UCIP)10/31/2013:- 2-inch electric conduit on waterside- service pole on landside.- needs a cover on pressure relief valve. (P. Amatya - DWR) FIELD_STRUCT_DESC: 16-inch steel irrigation discharge pipe through the levee, 5.3 feet below the crown. Pump mounted on a pile structure in the river. Steel walkway to the pump. Pressure relief valve in a butterfly configuration at the apex of the pipe on the landside (LS). Two 36-inch concrete standpipes at the LS toe. Electrical conduit through the levee. Power pole at the LS toe. [Additional Reference(s): DWR Levee Log, 2005. USACE San Joaquin O&M Manual 7, April 1964, (HLM 5.77)]. FS Date: 10/2/2018 4:02:00 PM

WS view: pump on pile structure, walkway to the pump on levee slope.

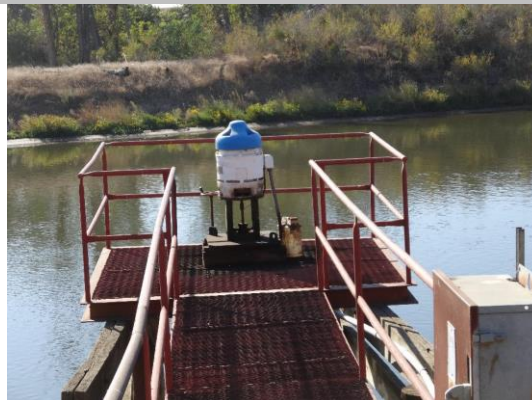
Photo 2 of 3 : UCIP\_FA\_2018\_53365\_42871.jpg

WS view: pump on pile structure in the stream. Oil leaking pump.

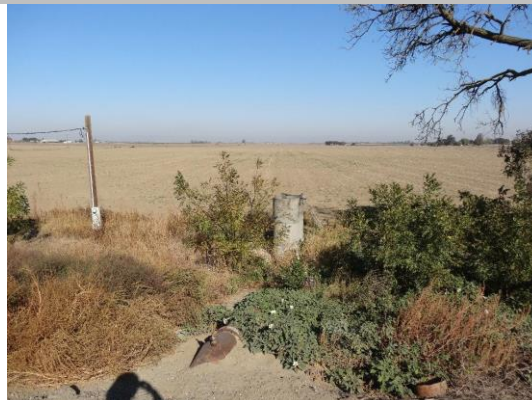
Photo 3 of 3 : UCIP\_FA\_2018\_53365\_42870.jpg

LS view: exposed pipe and pressure valve on levee slope. Two concrete standpipes on levee toe.

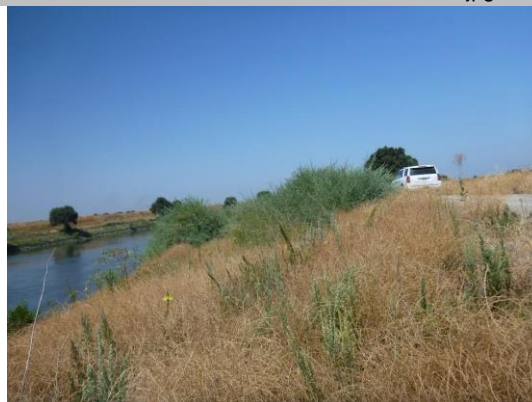
Photo 1 of 3 : LEVAL\_FA\_2018\_556\_4520.jpg

LM Start	<b>0.21</b>	Rating **	A/W	Issue No.	<b>37</b>
LM End	<b>0.23</b>	Issue Type +	Ma	Location *	
Category	Supplemental		GPS Latitude/Longitude		
			Start	End	
Item	2017 Storm Damage		37.808300 °	37.808400 °	
			-121.332000 °	-121.332200 °	
DWR ID	DWR_RD0544_02_f_2017_37				
Comment Code					
Inspector Comment					
Levee Evaluation Comments					
Description:Slope protection repairs are needed along the waterside slope due to erosion and riprap displacement from high water. Based upon levee inspections, it was determined the waterside levee slope is eroding, deteriorating, and degrading. The eroded levee sections need to be restored back to design standards to prevent further deterioration and damage.					
Site ID No:556					
Site Designation:LMA-462					
Repair Type: Erosion					
Rating:Area of Concern					
Field Date:8/16/2017					
Notes:

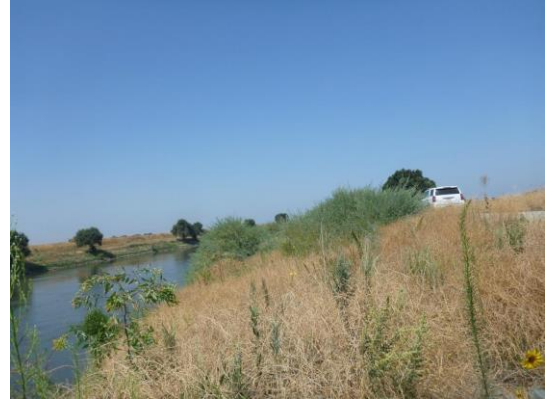
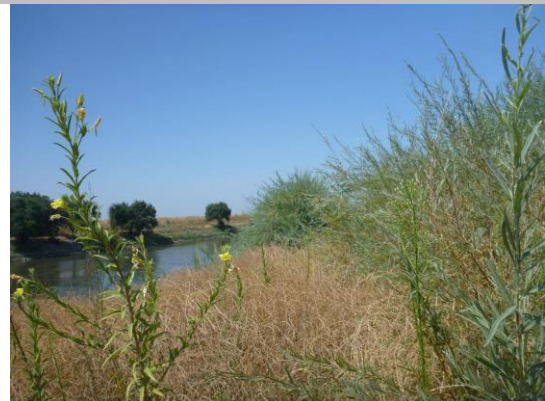
LM Start	0.21	Rating **	A/W	Issue No.	37 (cont)
LM End	0.23	Issue Type +	Ma	Location *	
Category	Supplemental			GPS Latitude/Longitude	
				Start	End
Item	2017 Storm Damage			37.808300 °	37.808400 °
				-121.332000 °	-121.332200 °
DWR ID	DWR_RD0544_02_f _ 2017_37				
Comment Code					
Inspector Comment					
Levee Evaluation Comments					
Description:Slope protection repairs are needed along the waterside slope due to erosion and riprap displacement from high water. Based upon levee inspections, it was determined the waterside levee slope is eroding, deteriorating, and degrading. The eroded levee sections need to be restored back to design standards to prevent further deterioration and damage.					
Site ID No:556					
Site Designation:LMA-462					
Repair Type: Erosion					
Rating:Area of Concern					
Field Date:8/16/2017					
Notes:

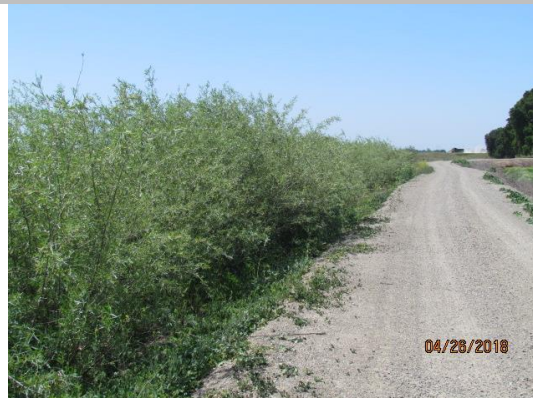
Photo 1 of 1 : FA\_2018\_RD0544\_109\_2\_20180906\_00002.jpg

LM Start	0.21	Rating **	U	Issue No.	2
LM End	0.26	Issue Type +	Ma	Location *	WS
Category	Earthen Levee			GPS Latitude/Longitude	
				Start	End
Item	Vegetation			37.808331 °	37.808576 °
				-121.331997 °	-121.332672 °
DWR ID	DWR_RD0544_02_s_2018_2				
Comment Code					
V2 : Remove the wild growth other than native grasses from the levee slopes.					
Inspector Comment

Looking southeast at dense veg on waterward slope. (Spring 2018)

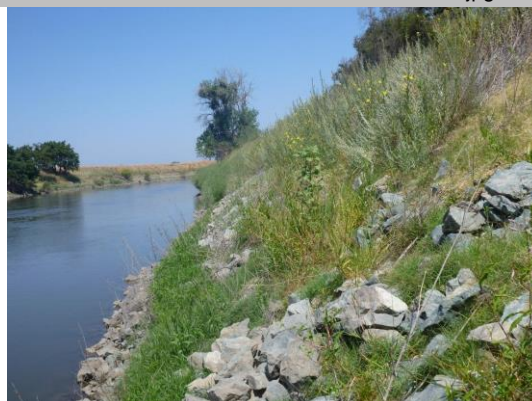
LM Start	0.57	Rating **	A/W	Issue No.	80 (cont)
LM End	0.58	Issue Type +	Ma	Location *	
Category	Supplemental			GPS Latitude/Longitude	
				Start	End
Item	2017 Storm Damage			37.812300 °	37.812400 °
				-121.335100 °	-121.335100 °
DWR ID	DWR_RD0544_02_f_2017_80				
Comment Code					
Inspector Comment					
Levee Evaluation Comments					
Description:Slope protection repairs are needed along the waterside slope due to erosion and riprap displacement from high water. Based upon levee inspections, it was determined the waterside levee slope is eroding, deteriorating, and degrading. The eroded levee sections need to be restored back to design standards to prevent further deterioration and damage.					
Site ID No:554					
Site Designation:LMA-460					
Repair Type: Erosion					
Rating:Area of Concern					
Field Date:8/16/2017					
Notes:

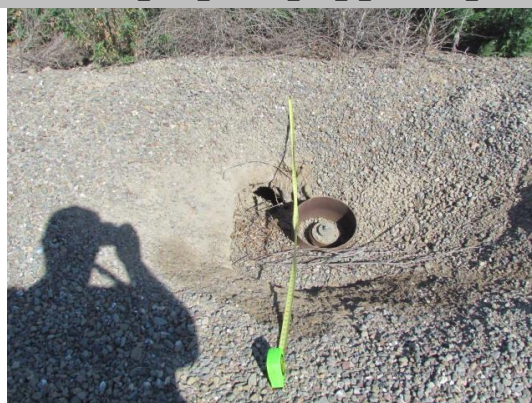
Photo 2 of 4 : FA\_2018\_RD0544\_109\_8\_20180906\_00007.jpg

Looking east at caving around siphon on waterside shoulder. (Spring 2012)

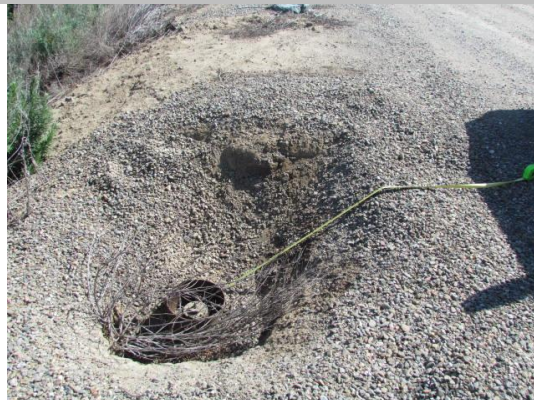
Photo 4 of 4 : FA\_2018\_RD0544\_109\_8\_20180906\_00009.jpg

LM Start	0.78	Rating **	U	Issue No.	8 (cont)	
LM End	0.78	Issue Type +	Ma	Location *	WS	
Category	Interior Drainage & Piping Systems			GPS Latitude/Longitude		
				Start		End
Item	Erosion Areas			37.815094 °		37.815094 °
				-121.333927 °		-121.333927 °
DWR ID	DWR_RD0544_02_s_2012_8					
Comment Code						
Inspector Comment						
Caving under and around siphon on waterside shoulder. No material 3' below pipe. Caving around siphon is 20" to 24" deep approximately 72" in diameter. During 2012 spring inspection hole appears to be enlarging.

Looking south at caving around siphon on waterside shoulder.(Spring 2012)

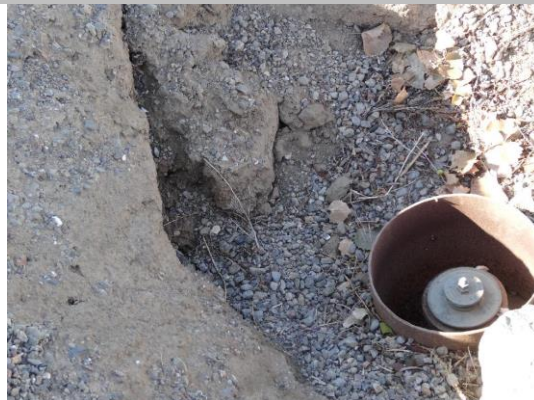
Photo 2 of 3 : UCIP\_FA\_2018\_53366\_44881.jpg

Comment Code						
Inspector Comment						
FS_ID:53366 DS_ID:22665 EP_NO: N/A Repair Type: Urgent Crossing Status: Found UCIP Comments: 10/2/2018 Same as last inspection; overgrown vegetation did not allow for visual inspection on LS so remains Urgent due to concern of erosion on WS (D. Sanoski - DWR UCIP).12/22/2016: Same as last inspection. Suspect siphon breaker is leaking due to depression around it. Two giant rodent holes through WS slope at siphon breaker. Siphon breaker is silted in. (K. Fazel - UCIP)10/31/2013:- 8 ft X 7 ft X 4 ft depression around siphon breaker on waterside slope.- no pipe visible on waterside due to dense vegetation.- electric conduit and service pole on landside. (P. Amatya - DWR) FIELD_STRUCT_DESC: 12-inch steel drainage discharge pipe through the levee, 4 feet below the crown. Pump in a drainage ditch off the landside (LS) toe. Siphon breaker on the waterside (WS) slope. [Additional Reference(s): DWR Levee Log, 2005]. FS Date: 10/2/2018 4:06:00 PM

WS view: depression on levee slope around siphon breaker. Siphon breaker in steel pipe riser.

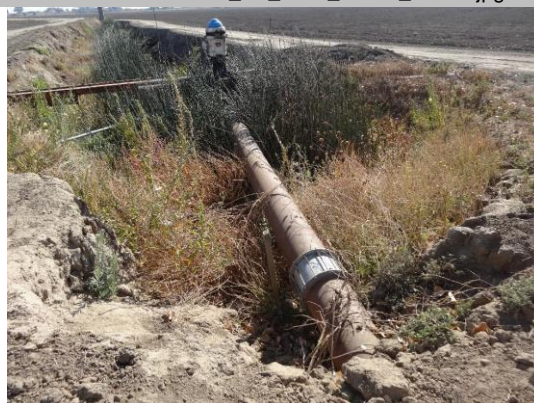
Photo 3 of 3 : UCIP\_FA\_2018\_53366\_44880.jpg

LS view: pump on timber support in drainage ditch. About 150 ft from levee center.

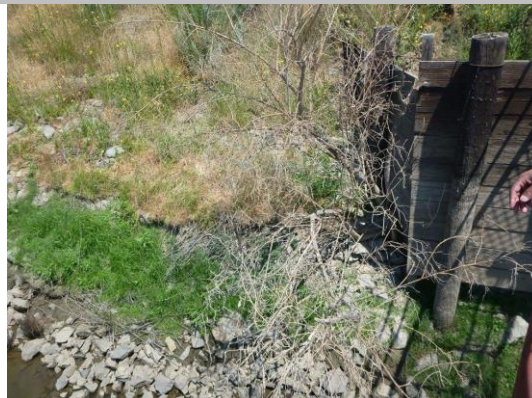
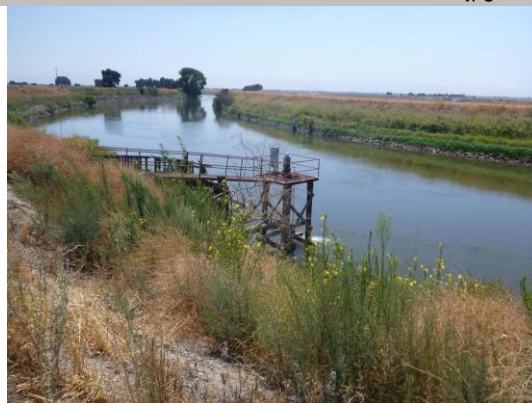
LM Start	1.01	Rating **	A/W	Issue No.	82 (cont)	
LM End	1.02	Issue Type +	Ma	Location *		
Category	Supplemental			GPS Latitude/Longitude		
				Start	End	
Item	2017 Storm Damage			37.818100 °	37.818200 °	
				-121.332800 °	-121.332800 °	
DWR ID	DWR_RD0544_02_f_2017_82					
Comment Code						
Inspector Comment						
Levee Evaluation Comments						
Description:Slope protection repairs are needed along the waterside slope due to erosion and riprap displacement from high water. Based upon levee inspections, it was determined the waterside levee slope is eroding, deteriorating, and degrading. The eroded levee sections need to be restored back to design standards to prevent further deterioration and damage.						
Site ID No:552						
Site Designation:LMA-458						
Repair Type: Erosion						
Rating:Area of Concern						
Field Date:8/16/2017						
Notes:

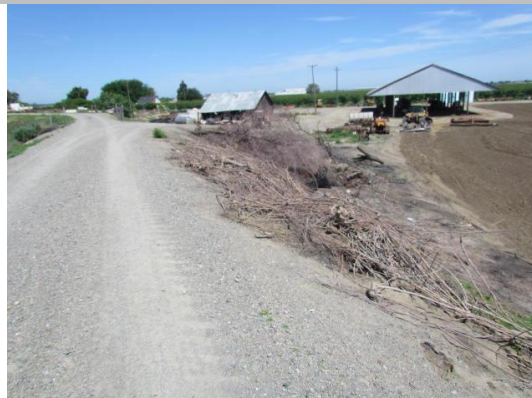
Photo 1 of 1 : FA\_2018\_RD0544\_109\_20\_20180906\_00019.jpg

LM Start	1.12	Rating **	M	Issue No.	20
LM End	1.12	Issue Type +	En	Location *	LS
Category	Earthen Levee			GPS Latitude/Longitude	
				Start	End
Item	Encroachments			37.819530 °	37.819530 °
				-121.333827 °	-121.333827 °
DWR ID	DWR_RD0544_02_s_2012_20				
Comment Code					
PR : Prunings					
Inspector Comment					
Landowner is stock piling prunings on landside slope and toe.

Looking southwest at pruning piles on landward slope.

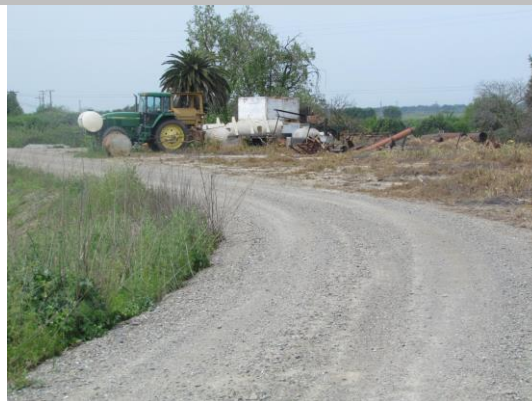
Photo 1 of 2 : FA\_2018\_RD0544\_109\_25\_20180906\_00023.jpg

LM Start	1.13	Rating **	U	Issue No.	25
LM End	1.19	Issue Type +	En	Location *	LS
Category	Earthen Levee			GPS Latitude/Longitude	
				Start	End
Item	Encroachments			37.819560 °	37.820083 °
				-121.333893 °	-121.334812 °
DWR ID	DWR_RD0544_02_s_2012_25				
Comment Code					
DE : Debris					
Inspector Comment

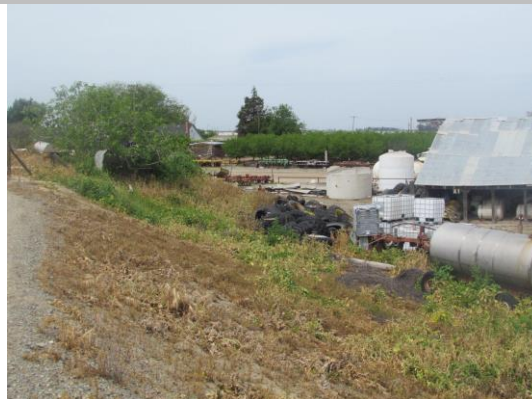
Photo 2 of 2 : FA\_2018\_RD0544\_109\_25\_20180906\_00024.jpg

Looking south at farm equipment stored on landward shoulder and slope.

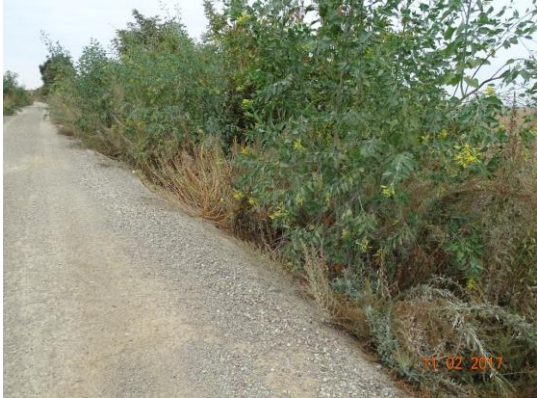
Photo 1 of 1 : FA\_2018\_RD0544\_109\_102\_20180906\_00094.jpg

Looking northwest at the landside slope.

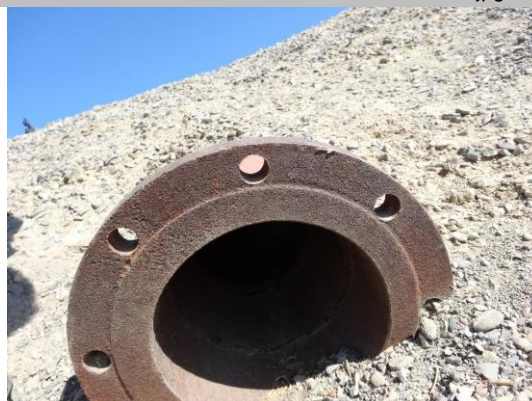
Photo 1 of 3 : UCIP\_FA\_2018\_46674\_44890.jpg

LM Start	1.38	Rating **	M	Issue No.	104
LM End	1.38	Issue Type +	En	Location *	
Category	Supplemental			GPS Latitude/Longitude	
				Start	End
Item	DWR UCIP Field Study			37.821380 °	37.821380 °
				-121.337835 °	-121.337835 °
DWR ID	22668				
Comment Code					
Inspector Comment					
FS_ID:46674 DS_ID:22668 EP_NO: N/A Repair Type: Non-Urgent Crossing Status: Found UCIP Comments: - slope erosion on landside. FIELD_STRUCT_DESC: 8-inch pipe of an unknown material or purpose through the levee, 3.5 feet below the crown. Pipe open on both ends, 1991. Steel pipe riser on the landside (LS), but not sure whether it is connected to the pipe. [Additional Reference(s): DWR Levee Log, 2005]. FS Date: 10/31/2013

WS view: steel pipe on levee slope with opened end.

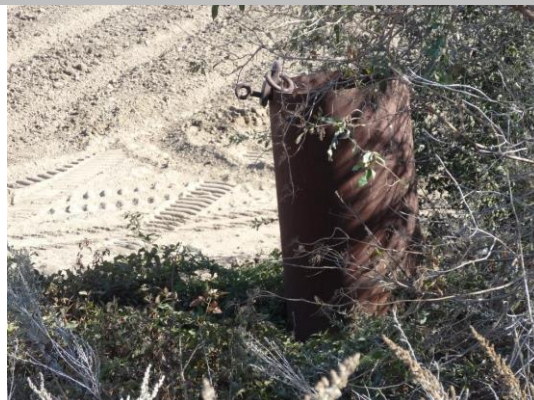
Photo 3 of 3 : UCIP\_FA\_2018\_46674\_44888.jpg

LM Start	1.38	Rating **	M	Issue No.	104 (cont)	
LM End	1.38	Issue Type +	En	Location *		
Category	Supplemental			GPS Latitude/Longitude		
				Start	End	
Item	DWR UCIP Field Study			37.821380 °	37.821380 °	
				-121.337835 °	-121.337835 °	
DWR ID	22668					
Comment Code						
Inspector Comment						
FS_ID:46674 DS_ID:22668 EP_NO: N/A Repair Type: Non-Urgent Crossing Status: Found UCIP Comments: - slope erosion on landside. FIELD_STRUCT_DESC: 8-inch pipe of an unknown material or purpose through the levee, 3.5 feet below the crown. Pipe open on both ends, 1991. Steel pipe riser on the landside (LS), but not sure whether it is connected to the pipe. [Additional Reference(s): DWR Levee Log, 2005]. FS Date: 10/31/2013

LS view: steel pipe riser off the levee toe.

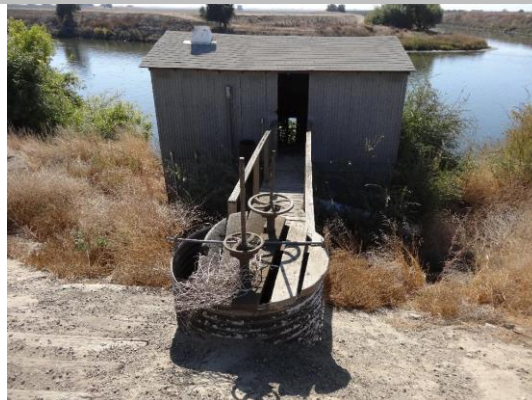
Photo 1 of 3 : UCIP\_FA\_2018\_24288\_42947.jpg

Comment Code						
Inspector Comment						
FS_ID:24288						
DS_ID:22669						
EP_NO: N/A						
Repair Type: Non-Urgent						
Crossing Status: Found						
UCIP Comments: - two pumps with 16" steel pipe and an abandoned pump with 10" pipe inside pump house.- CMP riser cover needs repair. - electric conduits on waterside and power pole on landside.						
FIELD_STRUCT_DESC: 24-inch steel irrigation discharge pipe through the levee, 14 feet below the crown. Pump in a pump house on the waterside (WS) berm. Slide gate in a corrugated metal pipe (CMP) riser on the WS slope. Two corrugated metal cutoff walls. Distribution box and power pole at the landside (LS) toe. [Additional Reference(s): DWR Levee Log, 2005. USACE San Joaquin O&M Manual 7, April 1964, (HLM 1.53)].						
FS Date: 10/31/2013

WS view: slide gate in CMP riser, walkway, and pump house on levee slope.

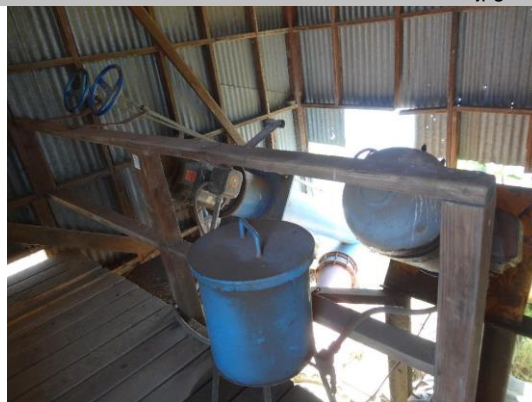
Photo 2 of 3 : UCIP\_FA\_2018\_24288\_42946.jpg

WS view: two pumps discharges water into CMP riser on levee slope.

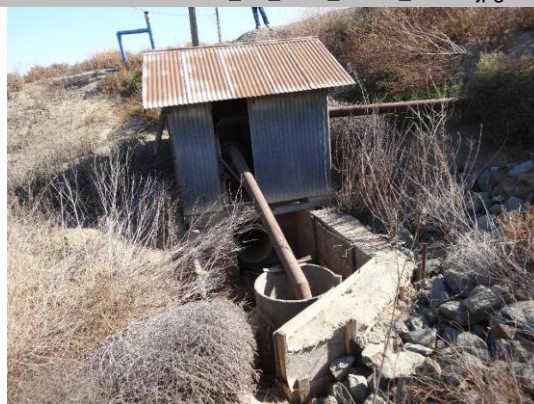
Photo 1 of 3 : UCIP\_FA\_2018\_24907\_44895.jpg

LM Start	1.52	Rating **	M	Issue No.	106	
LM End	1.52	Issue Type +	En	Location *		
Category	Supplemental			GPS Latitude/Longitude		
				Start		End
Item	DWR UCIP Field Study			37.822445 °		37.822445 °
				-121.339910 °		-121.339910 °
DWR ID	24716					
Comment Code						
Inspector Comment						
FS_ID:24907 DS_ID:24716 EP_NO: N/A Repair Type: Non-Urgent Crossing Status: Found UCIP Comments: No pipe and appurtenances found on waterside.Looks abandoned. FIELD_STRUCT_DESC: *ABANDONED* 8-inch steel drainage discharge pipe through the levee, at an unknown depth. Pump house at the landside (LS) toe. Air vent in a corrugated metal pipe (CMP) riser on the LS shoulder. Outlet on the waterside (WS) not visible. No positive closure device. Appears abandoned. FS Date: 10/31/2013

LS view: pipe, pump house, and appurtenances on levee slope.

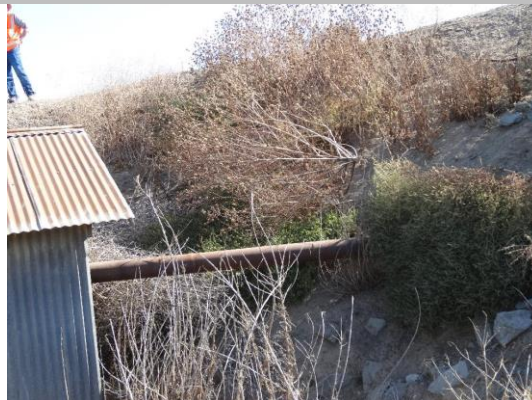
Photo 2 of 3 : UCIP\_FA\_2018\_24907\_44894.jpg

LM Start	1.52	Rating **	M	Issue No.	106 (cont)	
LM End	1.52	Issue Type +	En	Location *		
Category	Supplemental			GPS Latitude/Longitude		
				Start	End	
Item	DWR UCIP Field Study			37.822445 °	37.822445 °	
				-121.339910 °	-121.339910 °	
DWR ID	24716					
Comment Code						
Inspector Comment						
FS_ID:24907 DS_ID:24716 EP_NO: N/A Repair Type: Non-Urgent Crossing Status: Found UCIP Comments: No pipe and appurtenances found on waterside.Looks abandoned. FIELD_STRUCT_DESC: *ABANDONED* 8-inch steel drainage discharge pipe through the levee, at an unknown depth. Pump house at the landside (LS) toe. Air vent in a corrugated metal pipe (CMP) riser on the LS shoulder. Outlet on the waterside (WS) not visible. No positive closure device. Appears abandoned. FS Date: 10/31/2013

LS view: pipe daylights on levee slope.

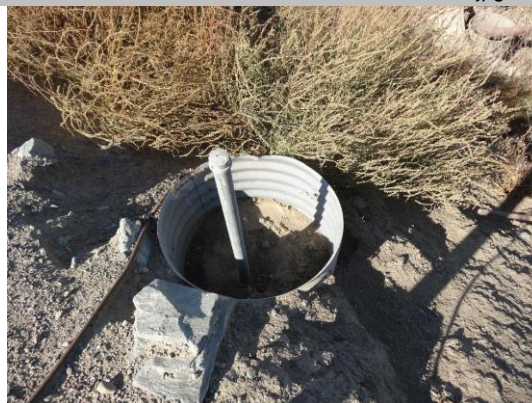
Photo 3 of 3 : UCIP\_FA\_2018\_24907\_44893.jpg

WS view: air vent on CMP riser on levee shoulder.

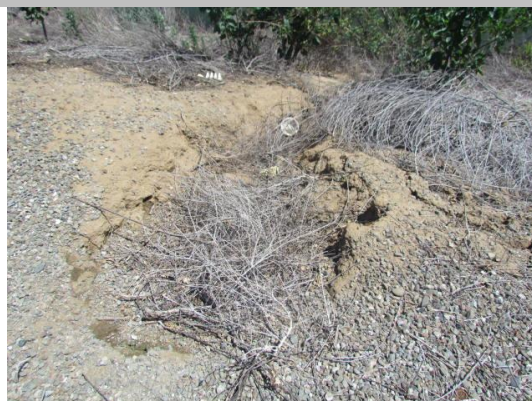
Photo 2 of 2 : FA\_2018\_RD0544\_109\_38\_20180906\_00032.jpg

LM Start	1.86	Rating **	U	Issue No.	38 (cont)	
LM End	1.86	Issue Type +	Ma	Location *	WS	
Category	Earthen Levee			GPS Latitude/Longitude		
				Start		End
Item	Erosion / Bank Caving			37.817983 °	37.817983 °	
				-121.341682 °	-121.341682 °	
DWR ID	DWR_RD0544_02_s_2015_38					
Comment Code						
E1 : Note and monitor erosion site.						
Inspector Comment						
Erosion/Caving on waterside shoulder and slope 18" x 6" x 15'.

Looking east at erosion/caving on waterward slope.

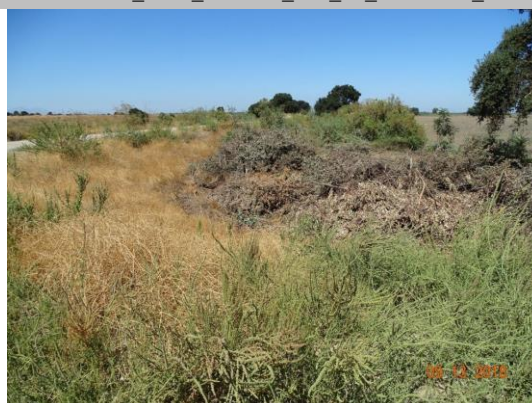
Photo 1 of 2 : FA\_2018\_RD0544\_109\_31\_20180919\_00128.jpg

LM Start	1.90	Rating **	U	Issue No.	31
LM End	1.90	Issue Type +	En	Location *	LS
Category	Earthen Levee			GPS Latitude/Longitude	
				Start	End
Item	Encroachments			37.817582 °	37.817582 °
				-121.342125 °	-121.342125 °
DWR ID	DWR_RD0544_02_f_2018_31				
Comment Code					
PR : Prunings					
Inspector Comment					
Large pruning pile at landward toe.

Looking south at large pruning pile at landward toe. (Fall 2018)

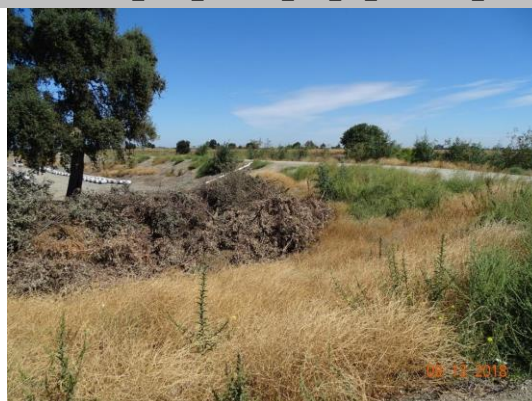
Photo 2 of 2 : FA\_2018\_RD0544\_109\_31\_20180919\_00129.jpg

Looking northwest t large pruning pile at landward toe. (Fall 2018)

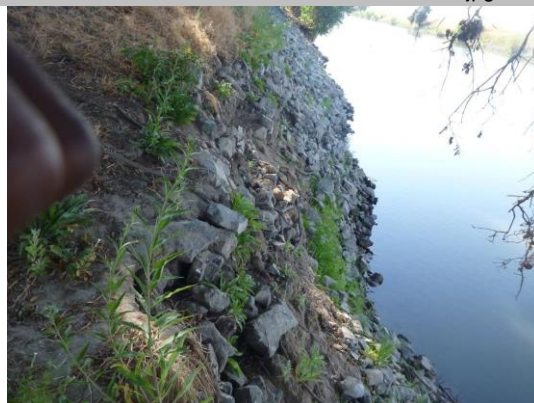
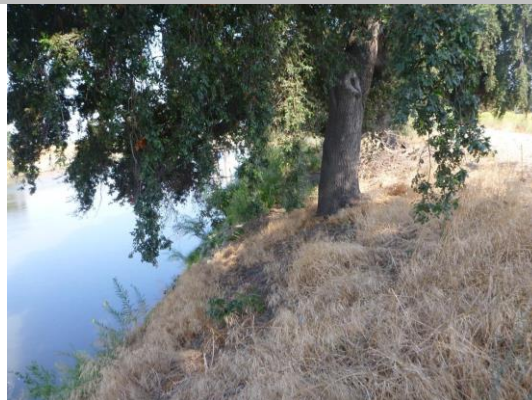
LM Start	<b>2.17</b>	Rating **	A/W	Issue No.	<b>87</b>							
LM End	<b>2.18</b>	Issue Type +	Ma	Location *								
Category	Supplemental		GPS Latitude/Longitude									
			Start	End								
Item	2017 Storm Damage		37.820300°	37.820300°								
			-121.345600°	-121.345700°								
DWR ID	DWR_RD0544_02_f_2017_87											
Comment Code												
Inspector Comment												
Levee Evaluation Comments Description: Slope protection repairs are needed along the waterside slope due to erosion and riprap displacement from high water. Based upon levee inspections, it was determined the waterside levee slope is eroding, deteriorating, and degrading. The eroded levee sections need to be restored back to design standards to prevent further deterioration and damage. Site ID No: 551 Site Designation: LMA-457 Repair Type: Erosion Rating: Serious Field Date: 8/18/2017 Notes:

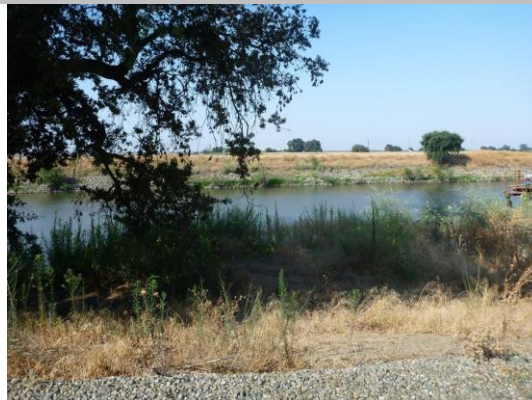
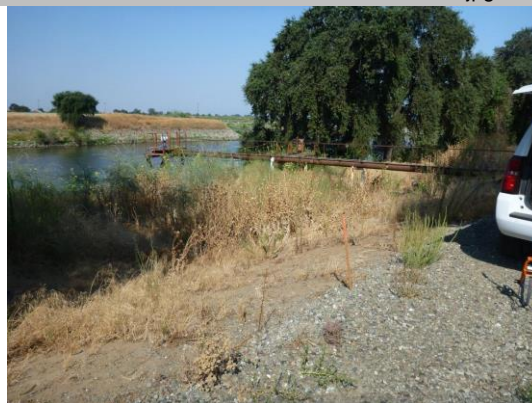
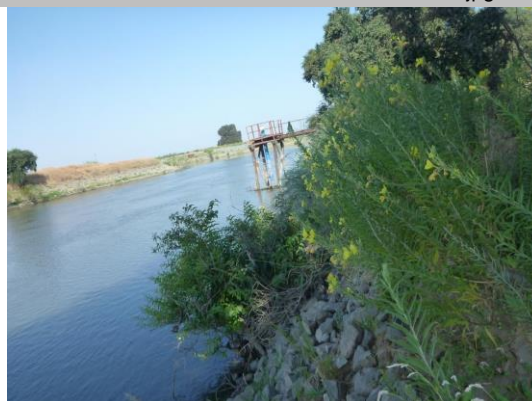
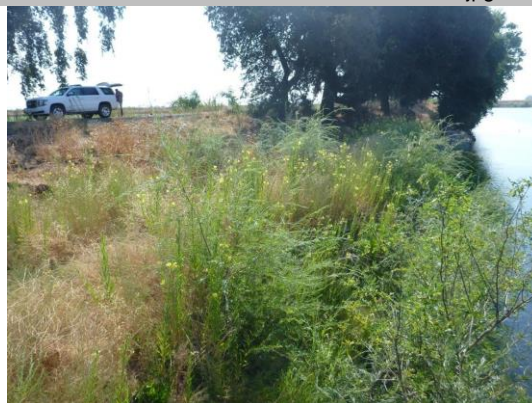
LM Start	2.18	Rating **	A/W	Issue No.	88
LM End	2.19	Issue Type +	Ma	Location *	
Category	Supplemental			GPS Latitude/Longitude	
				Start	End
Item	2017 Storm Damage			37.820400 °	37.820500 °
				-121.345800 °	-121.345900 °
DWR ID	DWR_RD0544_02_f_2017_88				
Comment Code					
Inspector Comment					
Levee Evaluation Comments					
Description:Slope protection repairs are needed along the waterside slope due to erosion and riprap displacement from high water. Based upon levee inspections, it was determined the waterside levee slope is eroding, deteriorating, and degrading. The eroded levee sections need to be restored back to design standards to prevent further deterioration and damage.					
Site ID No:550					
Site Designation:LMA-456					
Repair Type: Erosion					
Rating:Area of Concern					
Field Date:8/18/2017					
Notes:
